Enhancing Patient Safety through the Use of a Pharmaceutical Glass Designed To Prevent Cracked Containers

TECHNOLOGY/APPLICATION

ROBERT A. SCHAUT*, KYLE C. HOFF, STEVEN E. DEMARTINO, WILLIAM K. DENSON, and RONALD L. VERKLEEREN

Corning Incorporated, Corning, NY 14831 ©PDA, Inc. 2017

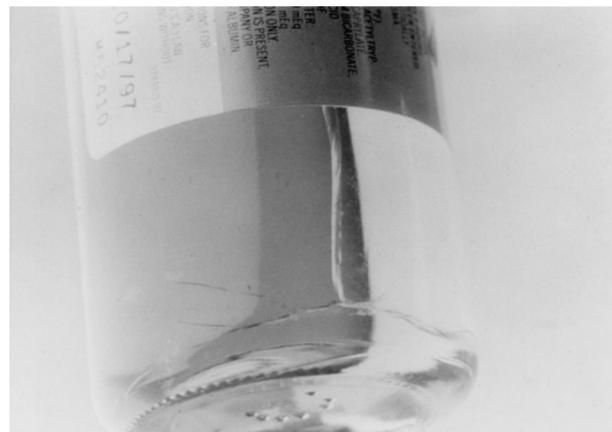
Figure 1

Cracked borosilicate vial of contaminated human albumin, which upon injection resulted in blood stream infections for patients (4).

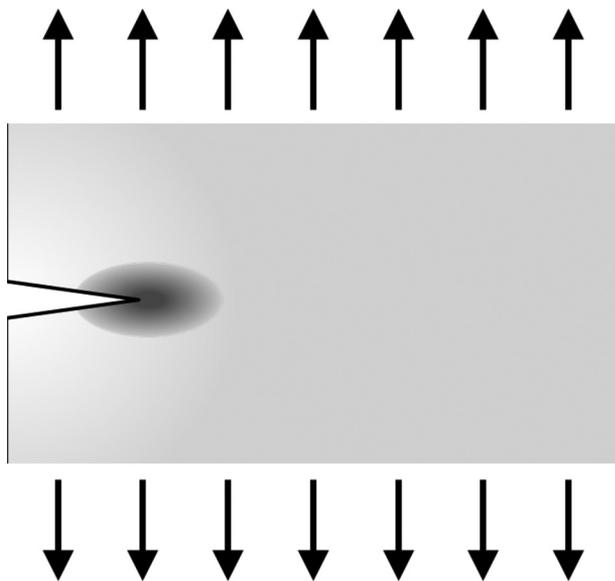
Cross-sectional schematic of a glass article under uniform applied tension, showing low level stress (grey shading) throughout the part and high stress concentration (dark grey shading) near the flaw tip.

placed in tension. The strength of glass under tension is limited in practice by *flaws*, which are cuts or gaps in the atomic bonds at the glass surface. Applied tension concentrates at the tip of flaws (i.e., checks, scratches, and even cracks), causing flaw extension (propagation) if the concentrated tension exceeds the strength of individual atomic bonds. Figure 2 illustrates the stress concentration at the flaw tip when the sample is experiencing uniform tension. Flaw extension can stop if the applied tension decreases over time, or if the flaw grows into a region of low tension. If the applied tension is sufficiently uniform and outlasts the flaw propagation, the flaw will extend (both through the wall thickness and away from the origin), and the container will break. Cracks occur whenever the stress applied allows the flaw to extend through the wall thickness, but the propagation stops before the container breaks. Cracks occur (and are stable) in conventional glass containers because they contain only minimal residual stresses, driven low by thermal annealing during forming.

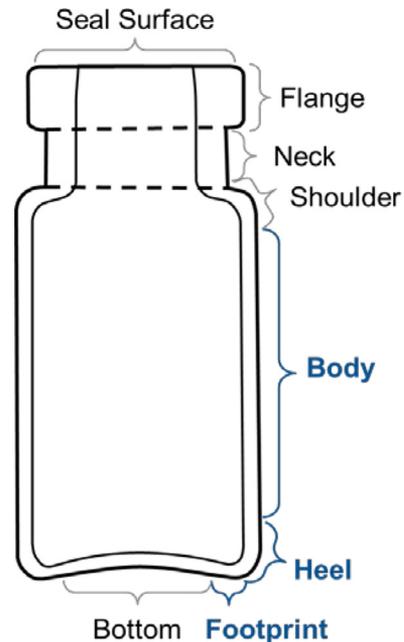
Figure 3

Vial schematic labeled with common locations. The highlighted regions (Body, Heel, & Footprint) show where more than 90% of cracks are introduced.

A survey of failed vials was conducted to determine the most common locations of cracks in borosilicate containers. Type I borosilicate vials returned to pharmaceutical companies due to the presence of cracks were shared with Corning Incorporated for this study. The returned containers included a wide range of dimensions (3 to 40 mL) and both molded and tubular forming methods. Modern fractographic techniques (16) were applied to determine the origin and categorize each crack location. The location categories are illustrated in Figure 3. In total, 81 cracked vials were inspected, and the results showed that more than 90% of cracks occur in the heel, footprint, and body regions. The remaining regions (bottom, shoulder, neck, flange, seal surface) experienced cracks much less frequently (<10%).

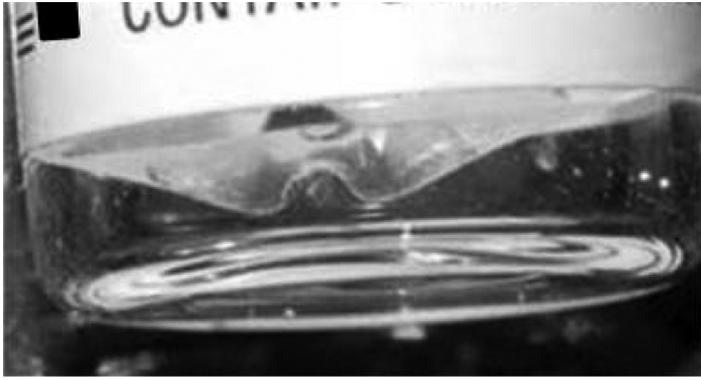
Figure 4

Photograph of a borosilicate vial returned from the field with a bump check crack that extends through the glass wall that was formed during shipping to the health care facility.

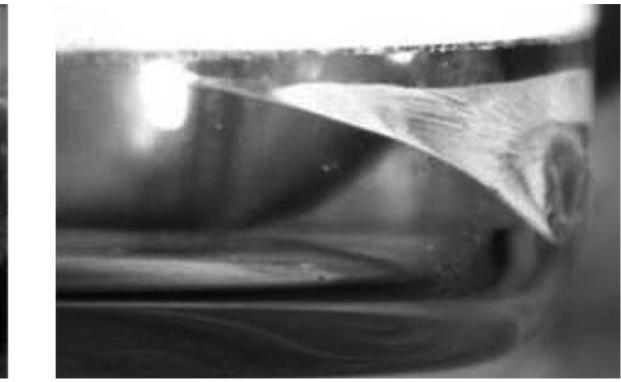
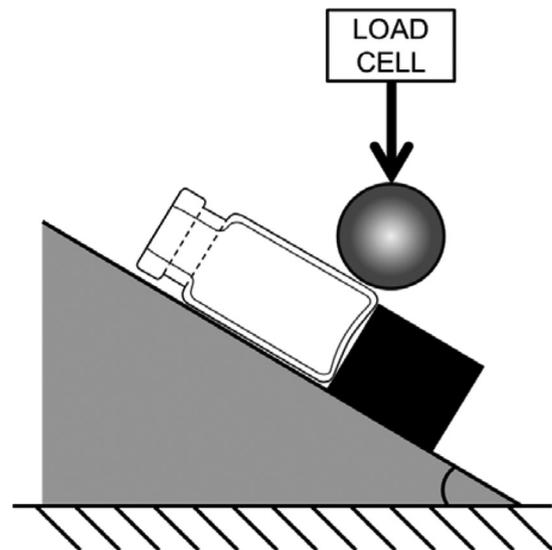
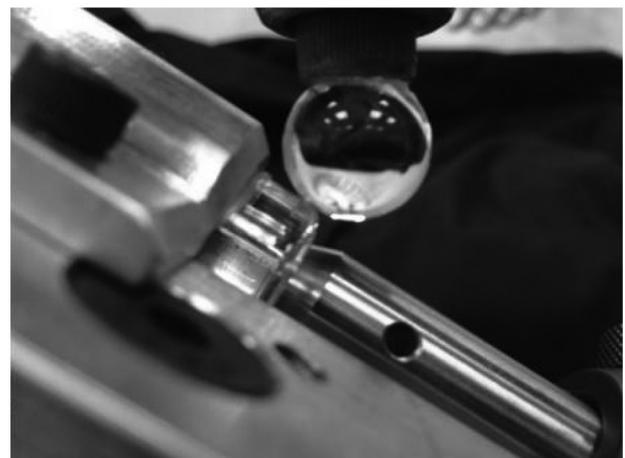
Mechanical testing equipment designed to replicate the features of a bump check crack by loading a vial heel with a sacrificial borosilicate glass ball.

Figure 5 shows a schematic of the experimental setup used to replicate this defect: a 3 mL vial placed on a 33° sine plate fixture in a 5 kN load frame. The photograph in Figure 5 shows a 16 mm borosilicate ball positioned to contact the vial sidewall approximately 2.5 mm from the footprint of the vial. A load is applied to the vial heel by vertical displacement of the ball (indicated by the arrow) to a predetermined peak load. During loading, a crack forms in the tested vial that persists after the load is removed. Cracks are consistently produced in the vials tested using this method.

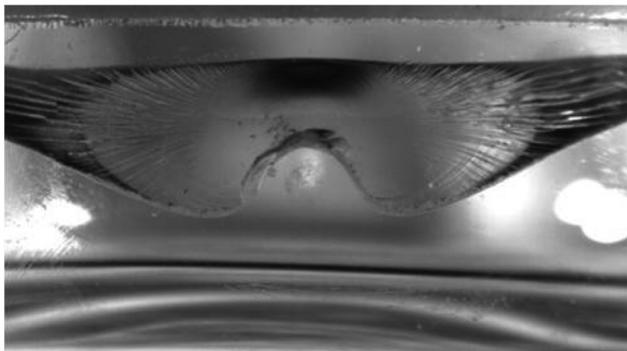
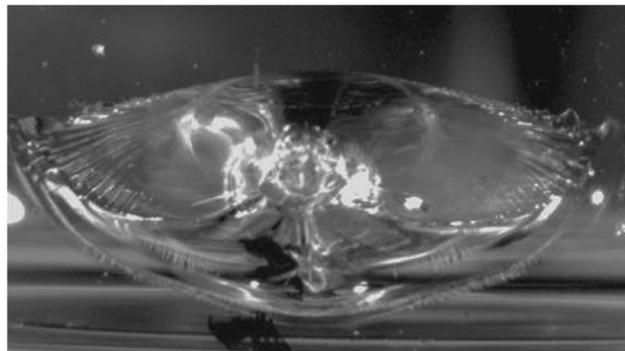
Optical microscopy comparison between a field return bump check crack and the laboratory replication, showing key fractographic features: frictive material transfer, crescent-shaped initial crack, and fracture propagating away from the origin creating “wing-shaped” features. The replication of these features demonstrates that the mechanical testing equipment is able to generate bump check cracks in borosilicate vials.

Figure 6 compares optical microscope images of a representative field return bump check defect to a representative defect created by this experimental setup. Both checks contain evidence of frictive material transfer near the conical center of the crack as well as wing-shaped fractures extending from the origin. Differences in features between samples will exist due to differences in loading rate, peak load, and other unique surface characteristics of each specimen. Despite these differences, the figures show replication of the key bump check fractographic features in orientation and scale, indicating that the experimental setup is able to simulate the conditions that lead to bump check failures.

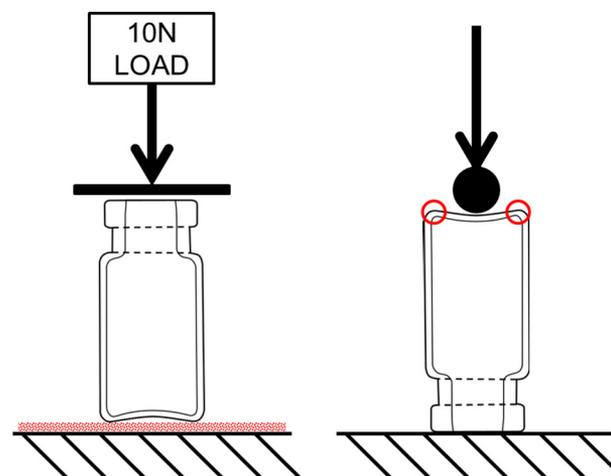
Figure 7

Schematic of two-step process of creating lens cracks. At left, the borosilicate glass vial is pressed into silicon carbide fixed abrasive paper (textured surface contacting vial footprint) with a 10N load, creating initial surface damage in the footprint region. At right, the center bottom is then lightly struck with a low-pressure pneumatic actuator putting the footprint in tension and propagating the initial damage to a lensing crack.

Lensing cracks were replicated via a two-step process: surface damage introduction followed by a dynamic impact (light strike). As illustrated in Figure 7, damage was first introduced to the footprint of 3 mL vials by contact with 90 grit silicon carbide-fixed abrasive grinding paper at a controlled normal load of 10 N. Second, the vial bottom center is lightly struck with a low-pressure pneumatic actuator putting the footprint in tension and propagating the initial damage to a lensing crack.

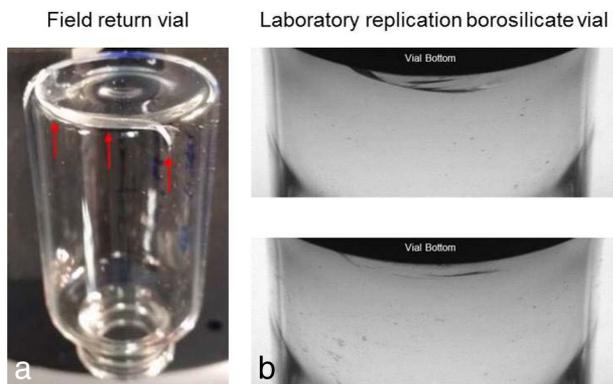
a) Field-returned borosilicate vials that experienced a lensing crack that propagated up the side-wall from additional applied stress but did not break the vial. b) Optical microscopy image of two vials from controlled lab experiments that replicated these lensing cracks.

Figure 8 compares the fractographic features of a lens crack from a field return with those generated by this method. The field return sample (Figure 8a) shows the crack propagating for about half of the circumference, before stopping in the heel or lower sidewall. These cracks are particularly difficult to detect due to the

narrow crack opening widths (preventing light reflection from its features) and the three dimensional curvature of the heel and footprint region. The microscope images (Figure 8b) show features of the lens cracks produced with this method. The photos (at

higher magnification than 8a) show the part of the crack system in the heel where the fracture terminates because the stress was removed.

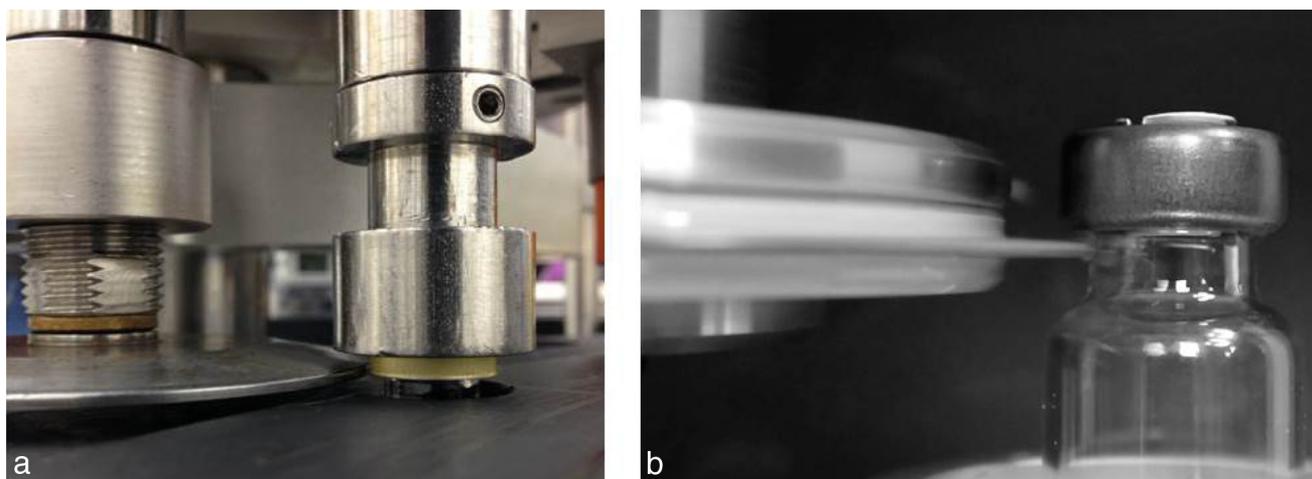
a) At left, seal crimping equipment configured to shape aluminum caps on vials. When operating, the crimping wheel (at lower left of image) is displaced a fixed distance toward the neck OD (at lower right), bending the aluminum cap under the flange. The vial being processed has larger neck OD, causing the crimping wheel to damage the glass surface in the vial neck. b) At right, rotary disc blade cutting into vial neck mimicking the location of damage from seal crimping equipment contact. Cutting through the vial neck with the rotary disc without the vial breaking demonstrates the stable nature of cracks in conventional glass vials. However, if the vial breaks before the disc can completely penetrate through the neck, that vial is not at risk to cause patient harm through the injection of contaminated drug product.

served in borosilicate vials capped by several methods, including rotating the vial against a static sealing rail system and by free-spinning displacement-driven crimping wheels. Because the introduction of these crack systems is difficult to control, the container response for defects in this region was evaluated using a rotary disc (low-speed diamond blade). Figure 9 illustrates how the rotary disc was used to damage the neck of a vial in a similar location to that of a misadjusted automatic crimping wheel. This method more consistently introduced severe damage in the vial neck, and manual inspection provided observations of differences in container response. The response of the vial to this type of insult can be categorized as either *cracked* (if the disc induces damage completely through the neck and the vial remains intact), or *broken* (if the vial flange separates from the neck before the disc induces damage completely through the neck).

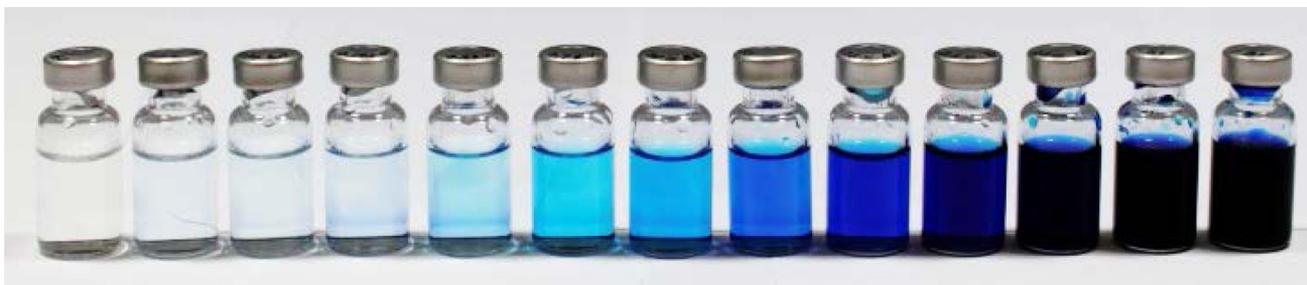
Figure 10

Positive control population for semi-quantitative comparison of dye ingress tests. The vial set shows (from left to right) a process blank (no methylene blue) and serial dilutions of methylene blue dye from 0.000049% to 0.1%.

As recommended by USP <1207.2>, reference solutions and negative controls were implemented to ensure consistency of results. Reference solutions were created by 11 serial dilutions of the 0.1% methylene blue solution between 0.05% and 0.000049% for semi-quantitative inspection. The test specimens were compared to these references and a process blank against a white background as shown in Figure 10. Negative controls were created using as-received (non-damaged) vials that were filled, stoppered, crimp-sealed under identical conditions, and vacuum-tested alongside each sample set to ensure any identified leaking vials were not a result of the crimping procedure. Any leaking of these negative controls during testing would have indicated poor sealing of the glass flange, rubber stopper, and aluminum cap closure system. No failures of the negative controls were observed in any of the test sets.

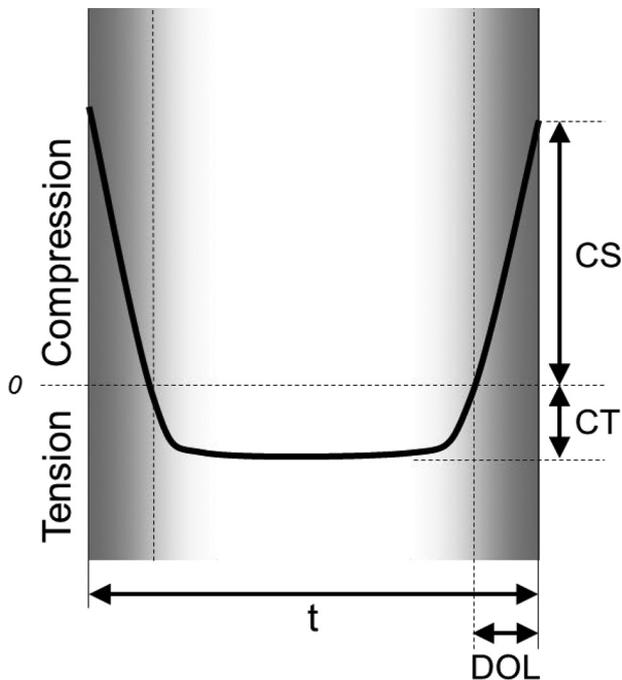
Figure 11

Illustration of the engineered stress profile resulting from ion-exchange of a thin-walled glass article, where the abscissa is the wall thickness (t , radial direction) and stress is the ordinate. High compressive stress (CS) is installed at the surfaces, and it decreases to the depth of the compressive stress layer (DOL). The compressive strain energy induced by this ion-exchange process is balanced by tensile strain energy, measurable as central tension (CT).

Ion-exchange strengthening (or chemical tempering) is another method that can impart this threshold strain energy. It is better suited to strengthen thin walls, glass compositions with low thermal expansion coefficient, and complex container geometries compared to thermal tempering (27). The process uses chemical gradients and interdiffusion to substitute larger ions from an external salt bath for smaller ions in the glass network. This substitution creates a compressive stress on the surface of the container and a balancing central tension over the thickness of the container wall, as illustrated in Figure 11. Because the stress profile is

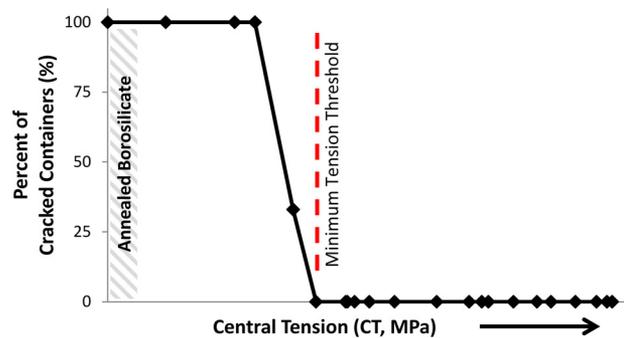
Percent of containers exhibiting stable cracks from damage introduction, as a function of increasing central tension. The response shows a clear “threshold” response, above which damage (severe enough to cause cracks) causes obvious breaking into fewer pieces with clean edges, facilitating detection.

An aluminosilicate glass, previously shown to be suitable for pharmaceutical use (28), was strengthened by the ion-exchange process as part of this study. A series of glass vials was prepared with increasing levels of central tension (or stored strain energy) by varying the ion-exchange process (time and temperature) to explore changes in the material’s fracture response. The containers were then subjected to controlled damage to observe the fracture response. Figure 12 illustrates the decrease in frequency of cracked vials produced as a function of increasing central tension (as surrogate for stored strain energy). The graph shows a clear “threshold” response, above which damage suitable to produce cracks in unstressed vials causes obvious breakage patterns (stable cracks are not maintained).

The absence of cracks in the aluminosilicate vials under the same conditions that consistently cracked the borosilicate vials demonstrates a significant difference in crack introduction behavior. The load needed to observe cracks will be just below that needed to break the container. The absence of cracks and onset of breaking at higher loads indicates that flaws were introduced that exceeded the aluminosilicate compressive layer depth. The binary response of the aluminosilicate vials (intact or broken) is expected because the stored strain energy was above the threshold shown in Figure 12.

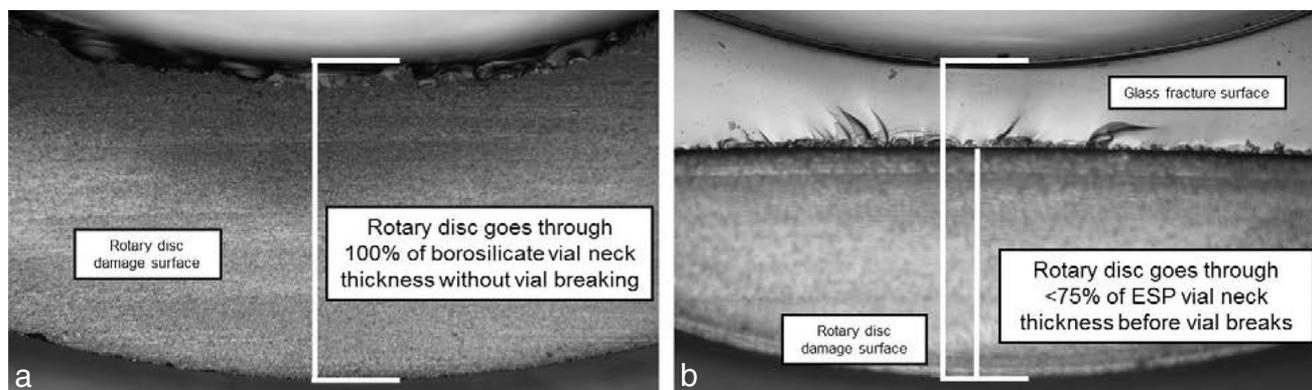
a) At left, an image of a conventional borosilicate vial neck showing rotary disc damage going through the neck thickness without flange separating from the neck. b) At right, an image of a strengthened aluminosilicate vial neck after a rotary disc damage demonstrating that the disc penetrated less than 75% of the way through the thickness before central tension from the engineered stress profile (ESP) initiated the glass fracture and separated the flange from the neck. This response prevents the vial from being at risk of containing a contaminated drug product that could be administered to a patient.

vials per glass type. The method was designed to demonstrate the inherent nature of crack stability in conventional glass vials and illustrate the release of stored strain energy via fracture with the strengthened aluminosilicate vials. Figure 13 compares representative micrographs of a conventional vial to a strengthened aluminosilicate vial after damage from a rotary disc, showing different fractographic responses. For the conventional borosilicate vial, the rotary disc completely penetrates through the vial neck with no fracture observed, only a roughened cut surface from the disc. This means that the rotary disc carved a large pathway through the neck thickness (an exaggerated crack) of the conventional borosilicate vial without the flange separating from the neck. For the strengthened aluminosilicate vial, the image shows that the rotary disc penetrates less than 75% through the thickness of the neck before the stored strain energy (central tension) caused the glass to fracture and the flange to separate from the neck.

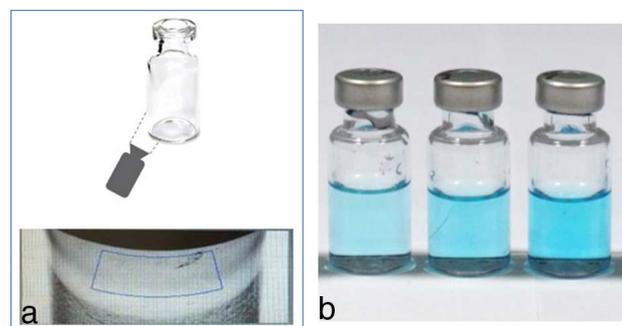
Figure 14

a) At left, an illustration shows the orientation of a state-of-the-art automated inspection camera designed to reject vials with cracks in the lensing crack region, with an example photo at bottom. b) At right, a photo of vials that were accepted as good by the automated inspection system shows that they clearly failed the dye ingress testing as indicated by the presence of blue dye.
