## Enhancing Patient Safety through the Use of a Pharmaceutical Glass Designed To Prevent Cracked Containers

Robert A. Schaut, Kyle C. Hoff, Steven E. Demartino, et al.

*PDA J Pharm Sci and Tech* **2017**, 71 511-528

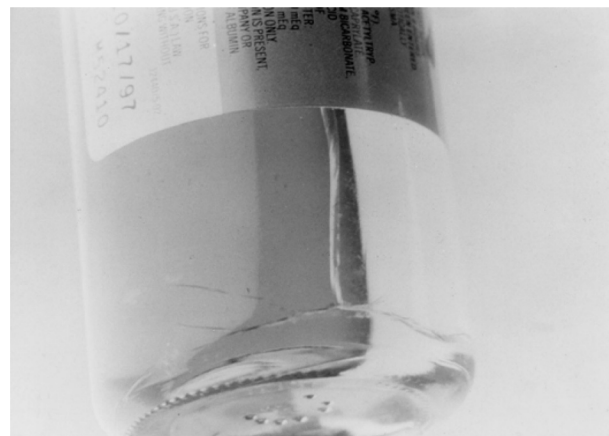
**Figure 1**

**Cracked borosilicate vial of contaminated human albumin, which upon injection resulted in blood stream infections for patients (4).**

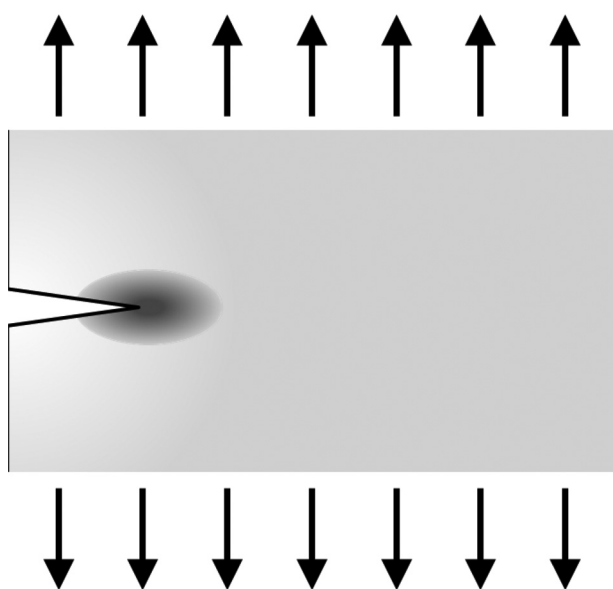
**Cross-sectional schematic of a glass article under uniform applied tension, showing low level stress (grey shading) throughout the part and high stress concentration (dark grey shading) near the flaw tip.**

placed in tension. The strength of glass under tension is limited in practice by *flaws*, which are cuts or gaps in the atomic bonds at the glass surface. Applied tension concentrates at the tip of flaws (i.e., checks, scratches, and even cracks), causing flaw extension (propagation) if the concentrated tension exceeds the strength of individual atomic bonds. Figure 2 illustrates the stress concentration at the flaw tip when the sample is experiencing uniform tension. Flaw extension can stop if the applied tension decreases over time, or if the flaw grows into a region of low tension. If the applied tension is sufficiently uniform and outlasts the flaw propagation, the flaw will extend (both through the wall thickness and away from the origin), and the container will break. Cracks occur whenever the stress applied allows the flaw to extend through the wall thickness, but the propagation stops before the container breaks. Cracks occur (and are stable) in conventional glass containers because they contain only minimal residual stresses, driven low by thermal annealing during forming.

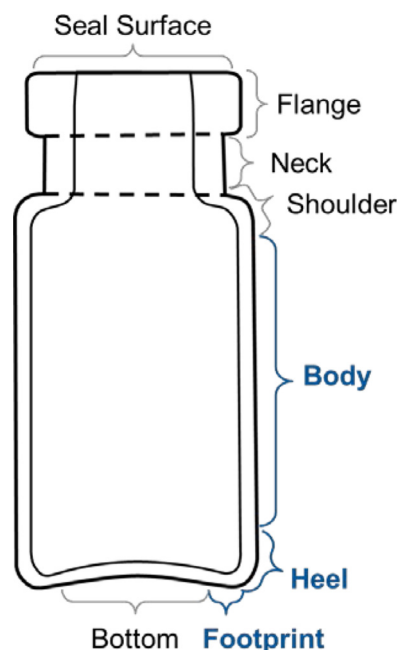
Figure 3

**Vial schematic labeled with common locations. The highlighted regions (Body, Heel, & Footprint) show where more than 90% of cracks are introduced.**

A survey of failed vials was conducted to determine the most common locations of cracks in borosilicate containers. Type I borosilicate vials returned to pharmaceutical companies due to the presence of cracks were shared with Corning Incorporated for this study. The returned containers included a wide range of dimensions (3 to 40 mL) and both molded and tubular forming methods. Modern fractographic techniques (16) were applied to determine the origin and categorize each crack location. The location categories are illustrated in Figure 3. In total, 81 cracked vials were inspected, and the results showed that more than 90% of cracks occur in the heel, footprint, and body regions. The remaining regions (bottom, shoulder, neck, flange, seal surface) experienced cracks much less frequently (<10%).

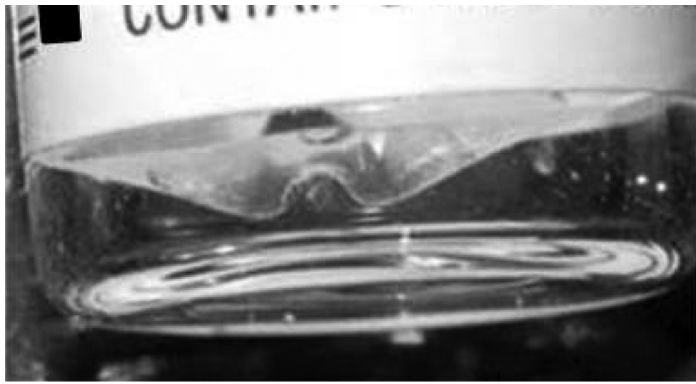
**Figure 4**

**Photograph of a borosilicate vial returned from the field with a bump check crack that extends through the glass wall that was formed during shipping to the health care facility.**

A bump check contains unique fractographic features such as friative transfer of material at the contact site, a crescent-shaped initial crack, and in more severe cases the fracture extends in opposite directions away from the origin along a curved path having a “wing-shaped” appearance. Figure 4 is a photograph of a crack in a field-returned Type I borosilicate vial that originates at a bump check and extends through the glass wall. This example is representative of the typical features of these defects, but not all bump check defects contain all of these features.

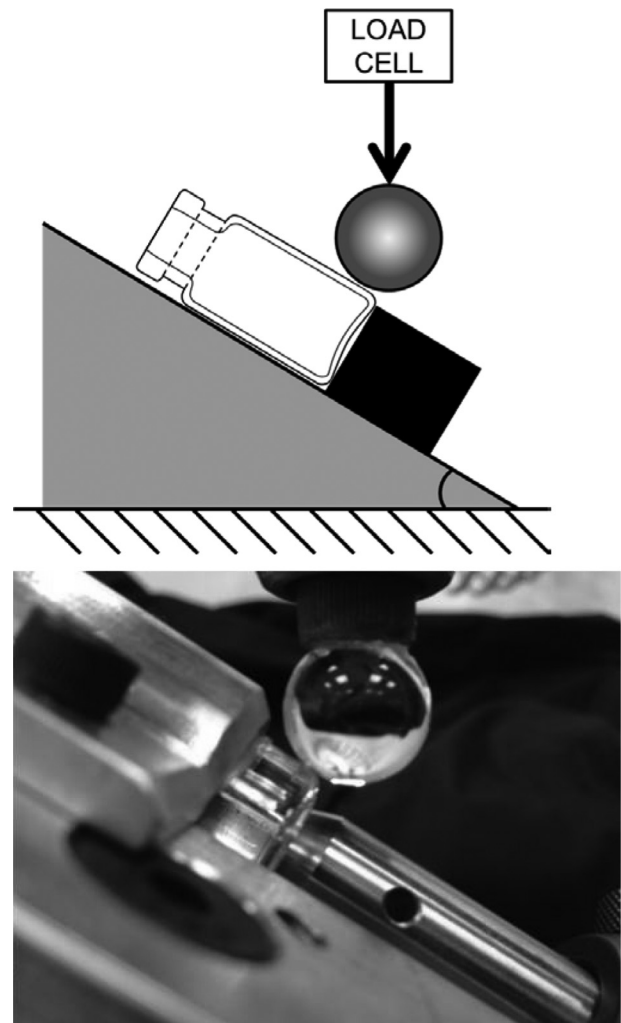
**Figure 5**

**Mechanical testing equipment designed to replicate the features of a bump check crack by loading a vial heel with a sacrificial borosilicate glass ball.**

Figure 5 shows a schematic of the experimental setup used to replicate this defect: a 3 mL vial placed on a 33° sine plate fixture in a 5 kN load frame. The photograph in Figure 5 shows a 16 mm borosilicate ball positioned to contact the vial sidewall approximately 2.5 mm from the footprint of the vial. A load is applied to the vial heel by vertical displacement of the ball (indicated by the arrow) to a predetermined peak load. During loading, a crack forms in the tested vial that persists after the load is removed. Cracks are consistently produced in the vials tested using this method.

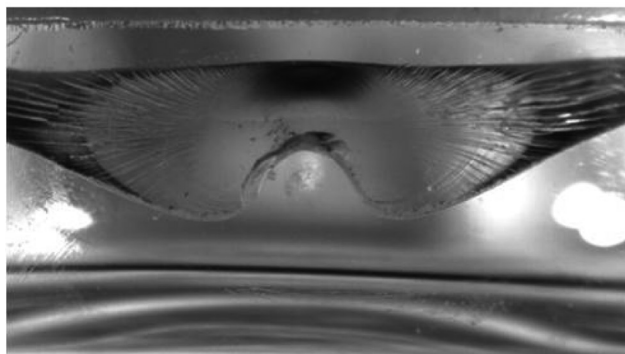
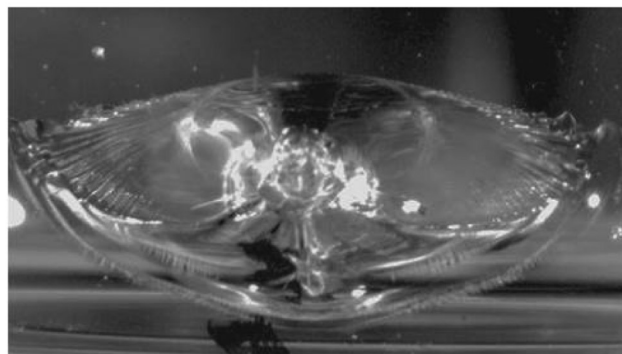
**Optical microscopy comparison between a field return bump check crack and the laboratory replication, showing key fractographic features: frictive material transfer, crescent-shaped initial crack, and fracture propagating away from the origin creating “wing-shaped” features. The replication of these features demonstrates that the mechanical testing equipment is able to generate bump check cracks in borosilicate vials.**

Figure 6 compares optical microscope images of a representative field return bump check defect to a representative defect created by this experimental setup. Both checks contain evidence of frictive material transfer near the conical center of the crack as well as wing-shaped fractures extending from the origin. Differences in features between samples will exist due to differences in loading rate, peak load, and other unique surface characteristics of each specimen. Despite these differences, the figures show replication of the key bump check fractographic features in orientation and scale, indicating that the experimental setup is able to simulate the conditions that lead to bump check failures.

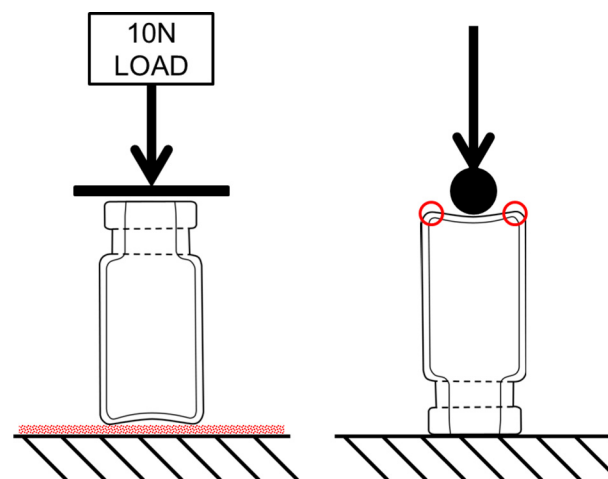
Figure 7

**Schematic of two-step process of creating lens cracks. At left, the borosilicate glass vial is pressed into silicon carbide fixed abrasive paper (textured surface contacting vial footprint) with a 10N load, creating initial surface damage in the footprint region. At right, the center bottom is then lightly struck with a low-pressure pneumatic actuator putting the footprint in tension and propagating the initial damage to a lensing crack.**

Lensing cracks were replicated via a two-step process: surface damage introduction followed by a dynamic impact (light strike). As illustrated in Figure 7, damage was first introduced to the footprint of 3 mL vials by contact with 90 grit silicon carbide–fixed abrasive grinding paper at a controlled normal load of 10 N. Second, the vial bottom center is lightly struck with a low-pressure pneumatic actuator putting the footprint in tension and propagating the initial damage to a lensing crack.

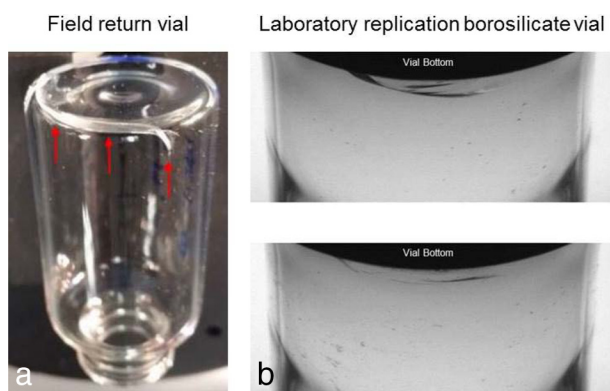
**Figure 8**

**a) Field-returned borosilicate vials that experienced a lensing crack that propagated up the side-wall from additional applied stress but did not break the vial. b) Optical microscopy image of two vials from controlled lab experiments that replicated these lensing cracks.**

Figure 8 compares the fractographic features of a lens crack from a field return with those generated by this method. The field return sample (Figure 8a) shows the crack propagating for about half of the circumference, before stopping in the heel or lower sidewall. These cracks are particularly difficult to detect due to the

narrow crack opening widths (preventing light reflection from its features) and the three dimensional curvature of the heel and footprint region. The microscope images (Figure 8b) show features of the lens cracks produced with this method. The photos (at

higher magnification than 8a) show the part of the crack system in the heel where the fracture terminates because the stress was removed.

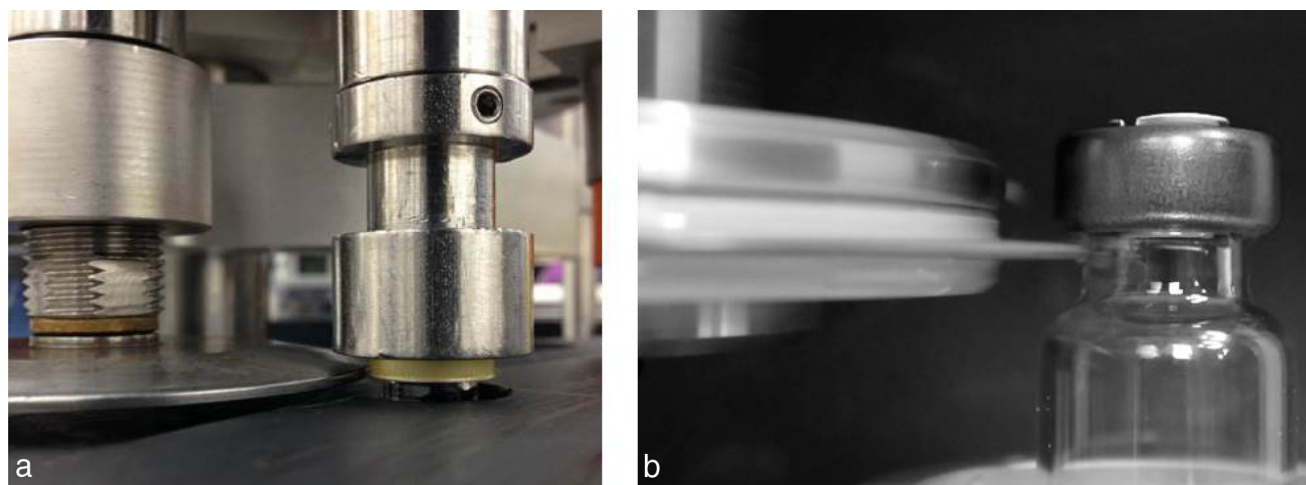
**Figure 9**

**a) At left, seal crimping equipment configured to shape aluminum caps on vials. When operating, the crimping wheel (at lower left of image) is displaced a fixed distance toward the neck OD (at lower right), bending the aluminum cap under the flange. The vial being processed has larger neck OD, causing the crimping wheel to damage the glass surface in the vial neck. b) At right, rotary disc blade cutting into vial neck mimicking the location of damage from seal crimping equipment contact. Cutting through the vial neck with the rotary disc without the vial breaking demonstrates the stable nature of cracks in conventional glass vials. However, if the vial breaks before the disc can completely penetrate through the neck, that vial is not at risk to cause patient harm through the injection of contaminated drug product.**

served in borosilicate vials capped by several methods, including rotating the vial against a static sealing rail system and by free-spinning displacement-driven crimping wheels. Because the introduction of these crack systems is difficult to control, the container response for defects in this region was evaluated using a rotary disc (low-speed diamond blade). Figure 9 illustrates how the rotary disc was used to damage the neck of a vial in a similar location to that of a misadjusted automatic crimping wheel. This method more consistently introduced severe damage in the vial neck, and manual inspection provided observations of differences in container response. The response of the vial to this type of insult can be categorized as either *cracked* (if the disc induces damage completely through the neck and the vial remains intact), or *broken* (if the vial flange separates from the neck before the disc induces damage completely through the neck).

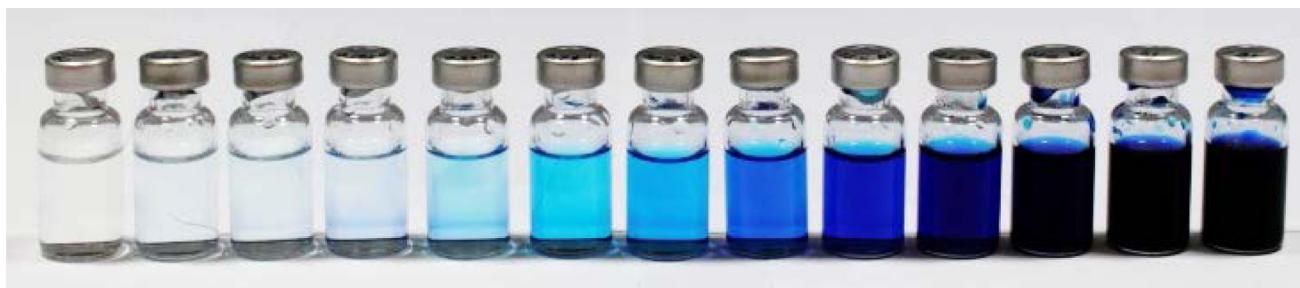
**Figure 10**

**Positive control population for semi-quantitative comparison of dye ingress tests. The vial set shows (from left to right) a process blank (no methylene blue) and serial dilutions of methylene blue dye from 0.000049% to 0.1%.**

As recommended by USP <1207.2>, reference solutions and negative controls were implemented to ensure consistency of results. Reference solutions were created by 11 serial dilutions of the 0.1% methylene blue solution between 0.05% and 0.000049% for semi-quantitative inspection. The test specimens were compared to these references and a process blank against a white background as shown in Figure 10. Negative controls were created using as-received (non-damaged) vials that were filled, stoppered, crimp-sealed under identical conditions, and vacuum-tested alongside each sample set to ensure any identified leaking vials were not a result of the crimping procedure. Any leaking of these negative controls during testing would have indicated poor sealing of the glass flange, rubber stopper, and aluminum cap closure system. No failures of the negative controls were observed in any of the test sets.

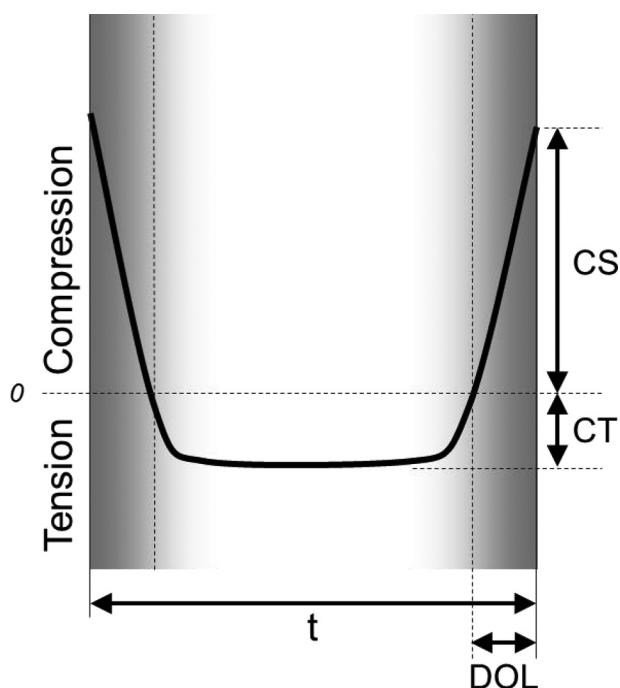
Figure 11

**Illustration of the engineered stress profile resulting from ion-exchange of a thin-walled glass article, where the abscissa is the wall thickness ( $t$ , radial direction) and stress is the ordinate. High compressive stress (CS) is installed at the surfaces, and it decreases to the depth of the compressive stress layer (DOL). The compressive strain energy induced by this ion-exchange process is balanced by tensile strain energy, measurable as central tension (CT).**

Ion-exchange strengthening (or chemical tempering) is another method that can impart this threshold strain energy. It is better suited to strengthen thin walls, glass compositions with low thermal expansion coefficient, and complex container geometries compared to thermal tempering (27). The process uses chemical gradients and interdiffusion to substitute larger ions from an external salt bath for smaller ions in the glass network. This substitution creates a compressive stress on the surface of the container and a balancing central tension over the thickness of the container wall, as illustrated in Figure 11. Because the stress profile is

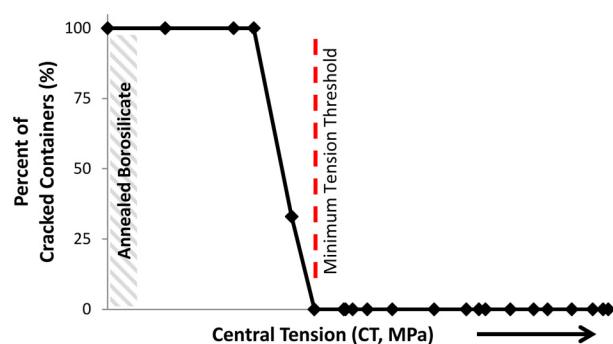
**Percent of containers exhibiting stable cracks from damage introduction, as a function of increasing central tension. The response shows a clear “threshold” response, above which damage (severe enough to cause cracks) causes obvious breaking into fewer pieces with clean edges, facilitating detection.**

An aluminosilicate glass, previously shown to be suitable for pharmaceutical use (28), was strengthened by the ion-exchange process as part of this study. A series of glass vials was prepared with increasing levels of central tension (or stored strain energy) by varying the ion-exchange process (time and temperature) to explore changes in the material’s fracture response. The containers were then subjected to controlled damage to observe the fracture response. Figure 12 illustrates the decrease in frequency of cracked vials produced as a function of increasing central tension (as surrogate for stored strain energy). The graph shows a clear “threshold” response, above which damage suitable to produce cracks in unstressed vials causes obvious breakage patterns (stable cracks are not maintained).

The absence of cracks in the aluminosilicate vials under the same conditions that consistently cracked the borosilicate vials demonstrates a significant difference in crack introduction behavior. The load needed to observe cracks will be just below that needed to break the container. The absence of cracks and onset of breaking at higher loads indicates that flaws were introduced that exceeded the aluminosilicate compressive layer depth. The binary response of the aluminosilicate vials (intact or broken) is expected because the stored strain energy was above the threshold shown in Figure 12.

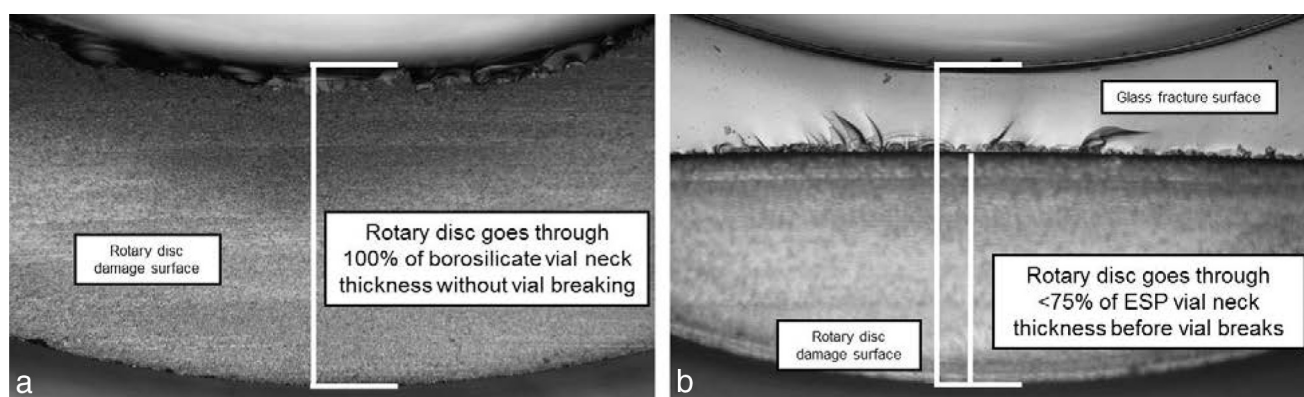
**Figure 13**

**a) At left, an image of a conventional borosilicate vial neck showing rotary disc damage going through the neck thickness without flange separating from the neck. b) At right, an image of a strengthened aluminosilicate vial neck after a rotary disc damage demonstrating that the disc penetrated less than 75% of the way through the thickness before central tension from the engineered stress profile (ESP) initiated the glass fracture and separated the flange from the neck. This response prevents the vial from being at risk of containing a contaminated drug product that could be administered to a patient.**

vials per glass type. The method was designed to demonstrate the inherent nature of crack stability in conventional glass vials and illustrate the release of stored strain energy via fracture with the strengthened aluminosilicate vials. Figure 13 compares representative micrographs of a conventional vial to a strengthened aluminosilicate vial after damage from a rotary disc, showing different fractographic responses. For the conventional borosilicate vial, the rotary disc completely penetrates through the vial neck with no fracture observed, only a roughened cut surface from the disc. This means that the rotary disc carved a large pathway through the neck thickness (an exaggerated crack) of the conventional borosilicate vial without the flange separating from the neck. For the strengthened aluminosilicate vial, the image shows that the rotary disc penetrates less than 75% through the thickness of the neck before the stored strain energy (central tension) caused the glass to fracture and the flange to separate from the neck.

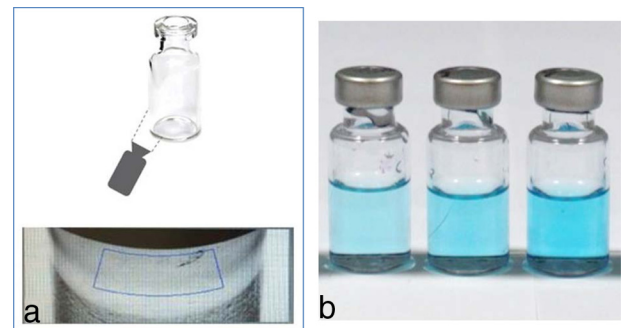
**Figure 14**

a) At left, an illustration shows the orientation of a state-of-the-art automated inspection camera designed to reject vials with cracks in the lensing crack region, with an example photo at bottom. b) At right, a photo of vials that were accepted as good by the automated inspection system shows that they clearly failed the dye ingress testing as indicated by the presence of blue dye.
